NASA Contractor Report 4664

# Analysis of Materials Flown on the Long Duration Exposure Facility: Summary of Results of the Materials Special Investigation Group

*H. Gary Pippin*

*H. Gary Pippin*  
*Boeing Defense & Space Group • Seattle, Washington*

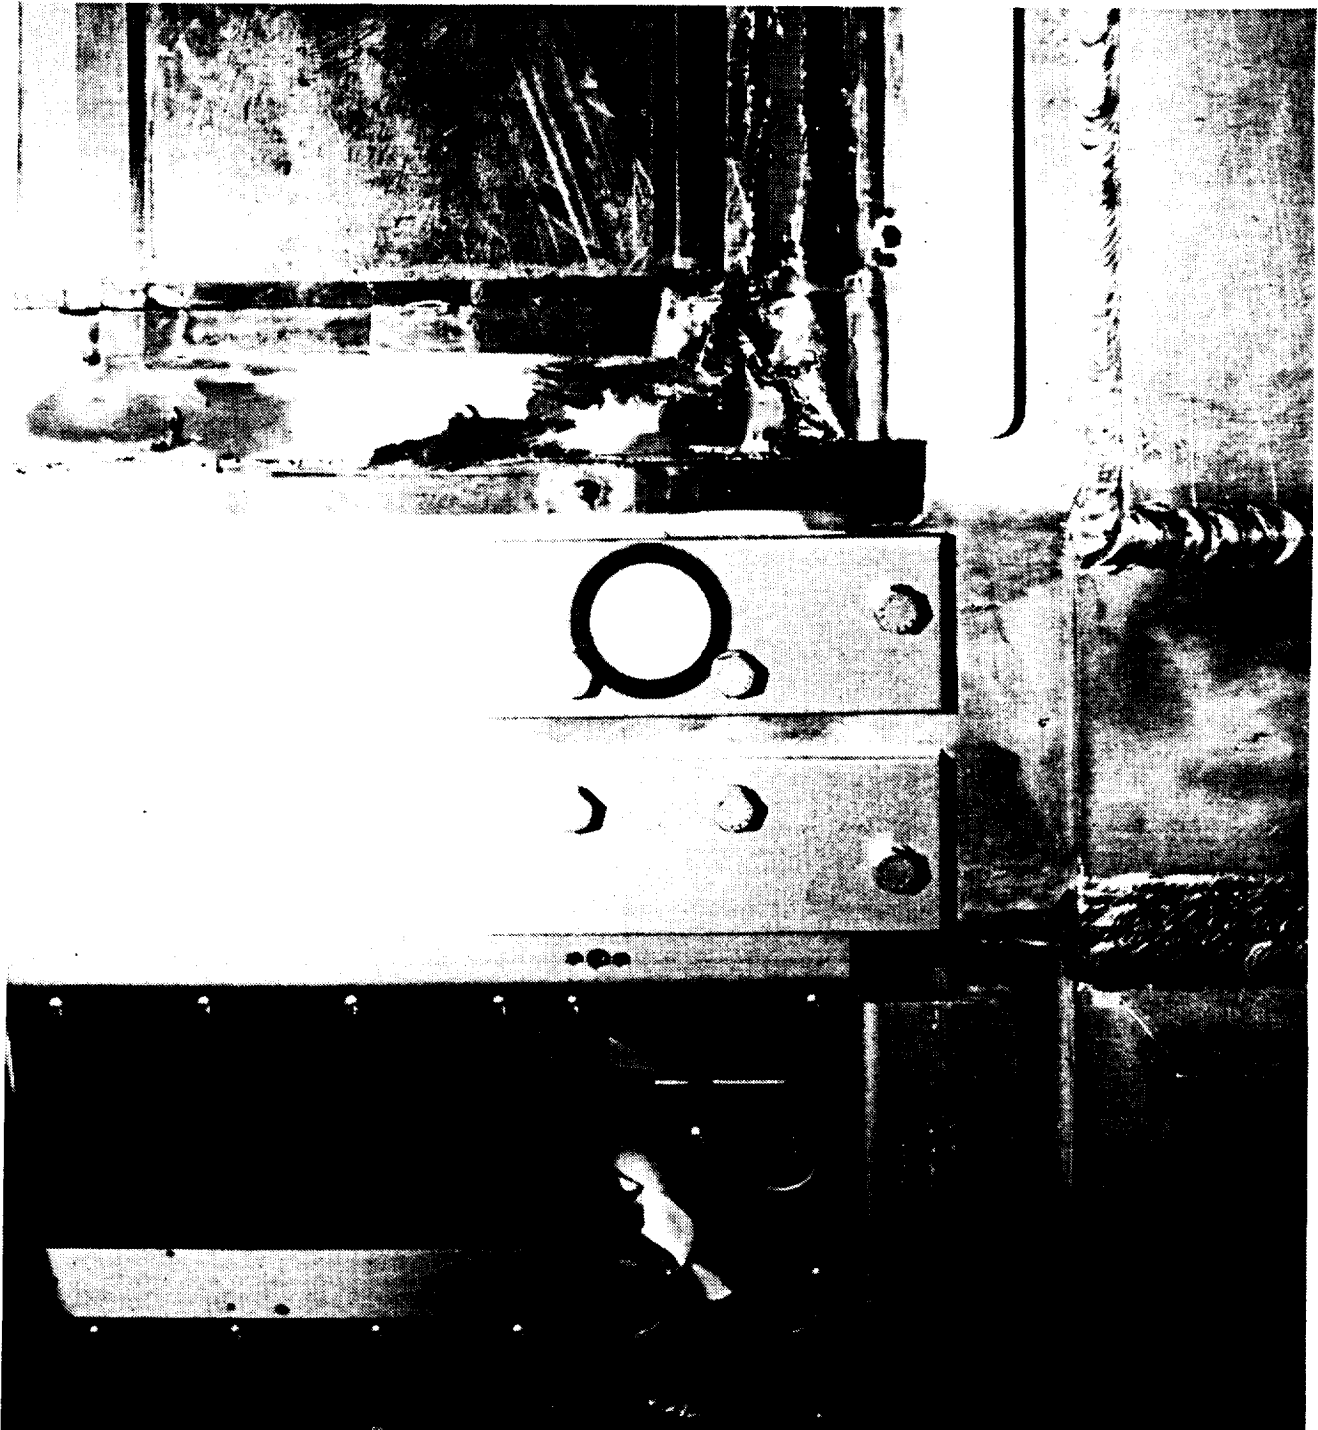
Figure 7.2-21 is a close-up showing corners of D9 and D10. Several of the thin film material specimens on D9 failed during flight and twisted, partially covering other specimens. This area of tray D9 was directly under a scuff plate and experienced exposure levels of atomic oxygen and solar UV reduced to about 1/3 in comparison with the remaining area of D9. Portions of the aluminized Kapton on AO054 (visible in the lower right hand corner of the photo) failed during flight as the Kapton was eroded by atomic oxygen. The extremely thin vapor deposited aluminum which remained when the Kapton was removed had essentially no mechanical integrity and disintegrated, distributing flakes over other locations. This damage is visible in the photograph.

Figure 7.2-21. NASA photo showing close-up of areas on trays D9 and D10.  
(Color figure C-31)
